Park Assist Repair

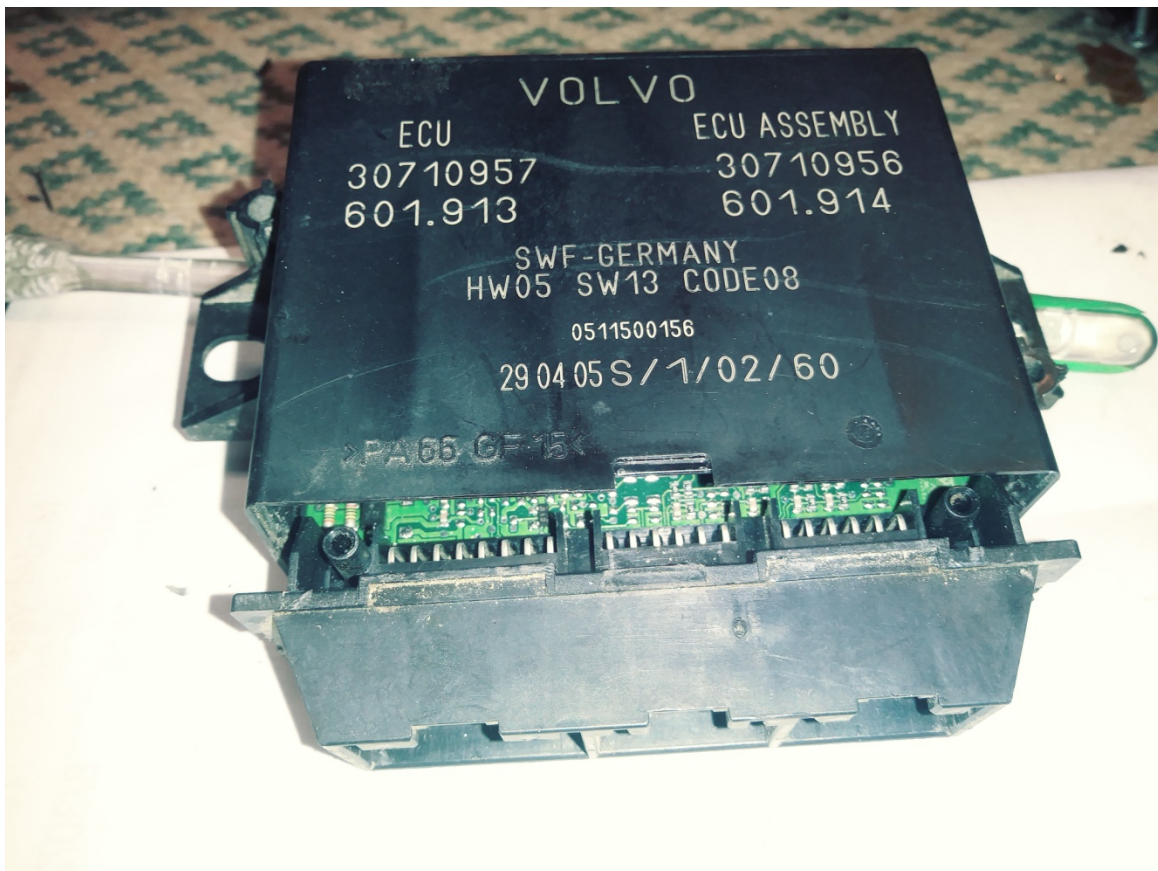
Curiosity is a terrible curse. Why did the original module fail? I needed to know. I opened the case and removed the circuit board and examined it closely.

Forensic analysis revealed water intruded the case and shorted two legs of the voltage regulator IC, vaporizing them and leaving telltale green-blue corrosion residue on the circuit board.

I thought, "I can fix this." A replacement voltage regulator IC chip (\$5) was ordered. I intend to remove the defective IC and replace it. The module should fully recover from this electronic surgery.

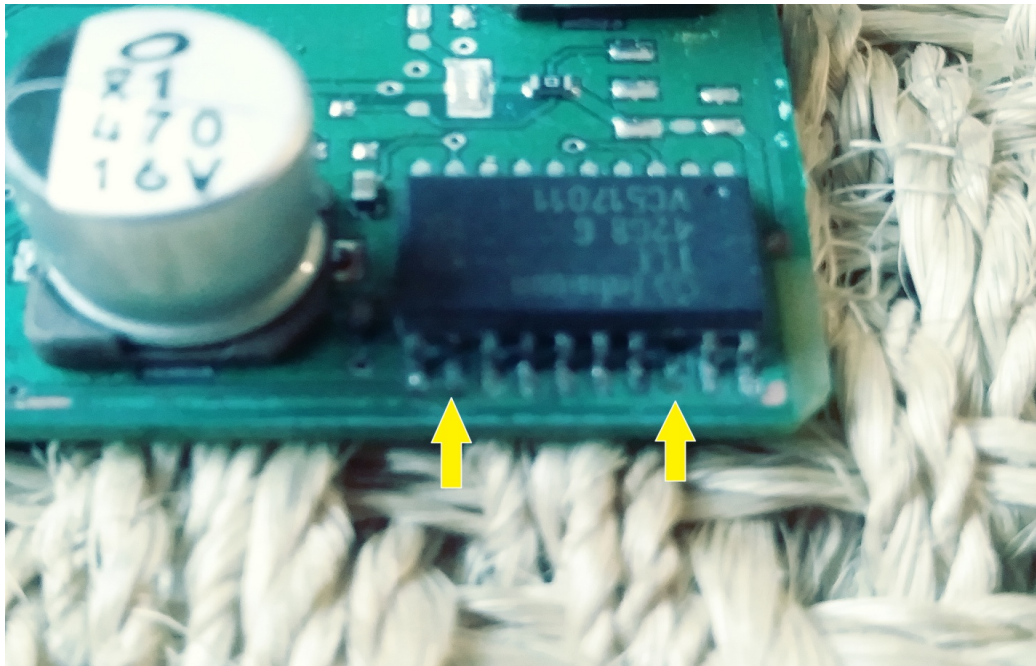
Arrows show missing legs

The module is attached to the body in the cargo well (left side), facing up below the tailgate hinge. That's when I recalled the Easter trip to Captiva Island Florida to meet my daughter and her family at a beach rental. I'd packed a 60 quart cooler with food, beverages and ice. The cooler was the last item packed, and closing the rear hatch pushed it snugly into the cargo bay. The cooler leaked, water dripped down and over the Park Assist Module into the storage well. Alternately, the water may have originated from a leaky bottle in the beverage cup immediately above the PAM. The rear facing seats were used to transport the grandchildren and they have to "hydrate"; hence, water bottle in the beverage cup.

It was in error the engineers thought an electrical module should be installed open end up near a beverage container and below the hatch hinge; thus, ensuring liquid intrusion. This circumstance should have been foreseen by alert engineers. The PAM should be installed with the open end down or the seams sealed with silicone to prevent liquid intrusion.
