# No Start Condition XC90 V8

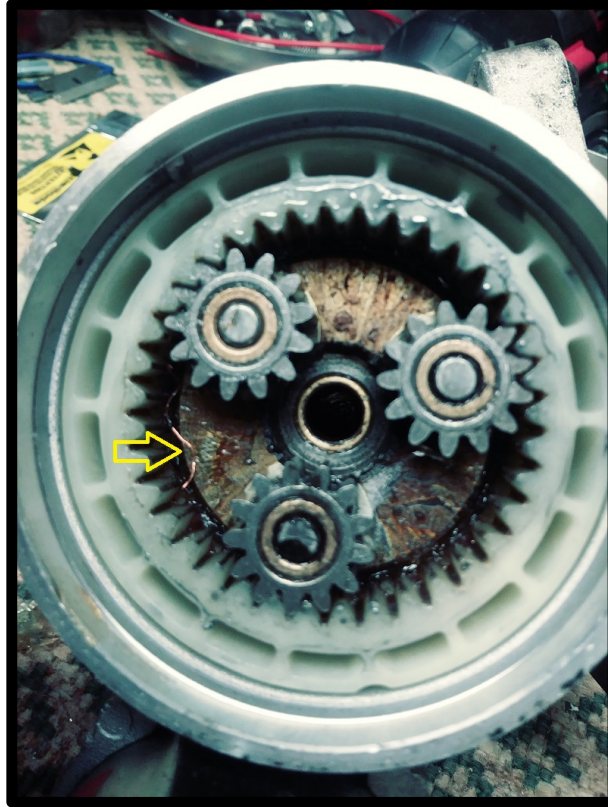
An examination of starter #3 disclosed wire bits in the armature housing and planetary gear assembly. Clearly, the windings were disintegrating.

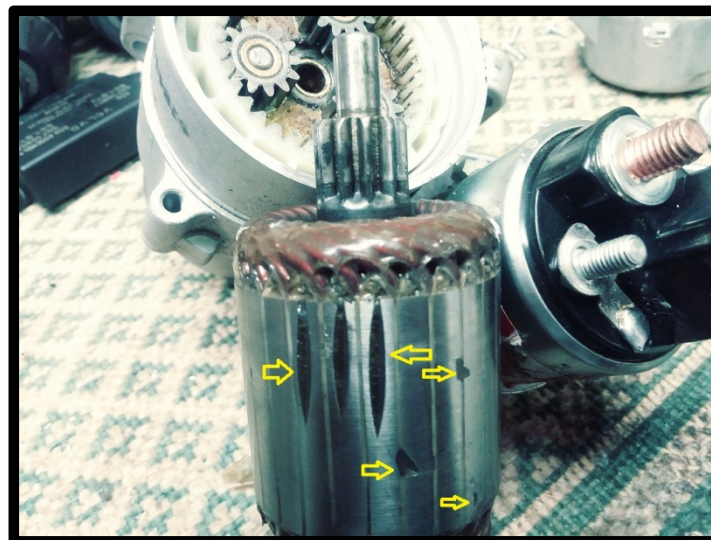
Using a multimeter, the armature windings were tested, most were shorted and the armature windings had several gouges where the winding integrity had been compromised.

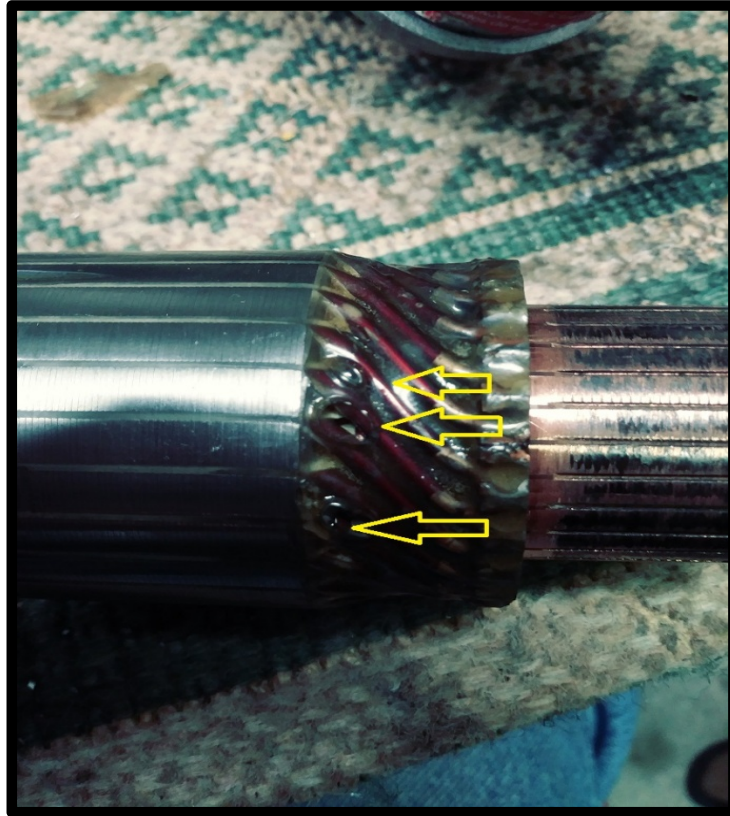
Heat Blistered Epoxy Insulation - high current load caused the wires to overheat.

The remanufactured starter was defective. The armature used in the rebuild should have been discarded. In my opinion, the Asian rebuilder's quality control was nonexistent.

The lowest price rebuild may not be an economic bargain, but it could be. Rebuilt electric components must be bench tested before leaving the parts store. This is why I insist the auto parts vendor test a rebuilt starter or alternator to verify worthiness and do not purchase these items online. Run 10 or more consecutive tests to bring the device to operating temperature. If it successfully completes 10 or more cycles, the likelihood it will function as intended.
