Bob's Diagnostic Tip

COP Trouble Code: Secondary Winding Resistance Problem

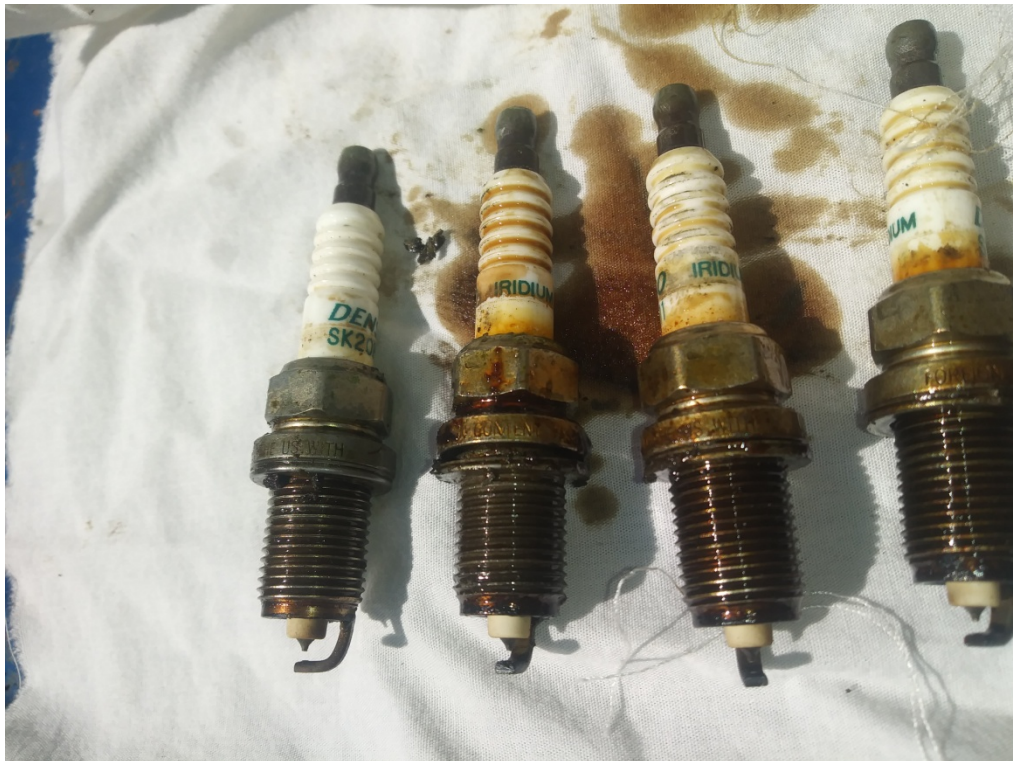
Six spark plug wells were filled with motor oil; both the spark plug and coil stem were submerged in motor oil. The engine management system and COPs adjusted for the unexpected capacitance and electrical resistance provided by the presence of oil. The spark plugs continued to fire; a testimony to the durability and reliability of the ignition system.

The valve cover gasket sealing the spark plug well from the cylinder head valve-camshaft area failed, allowing oil to be pushed into the spark plug wells by higher than normal internal engine pressure (Note: this vehicle is new to me and at 124K miles had 12-18 month interval oil changes.) indicating increased piston blow-by or a clogged PCV/oil recovery system. Diagnosis, remove the valve covers and replace the gaskets.

Three Bank 1 plugs submerged in oil

The valve cover gaskets on the 2006 and 2010 V8 XC90s were replaced. New plugs installed and the COPS cleaned and installed and the PCV system restored to negative pressure. No trouble codes after driving 100 miles. Success.

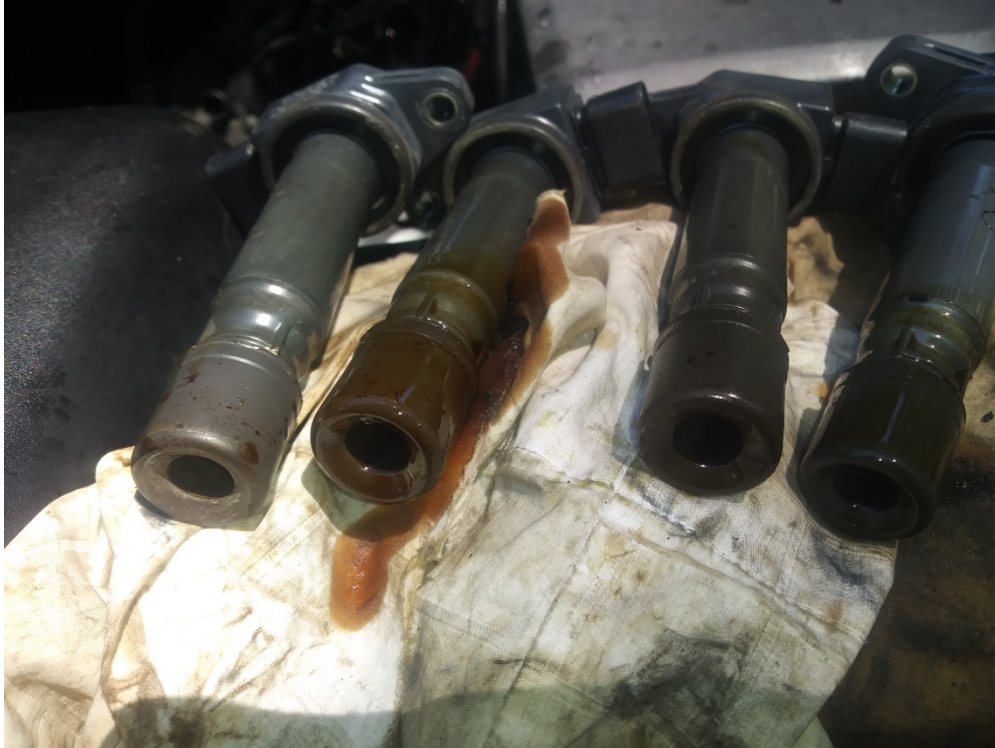
Oil Soaked COPS
