Bob's Service Tip

V8 Counter Balance Shaft

Replacement Work-Around

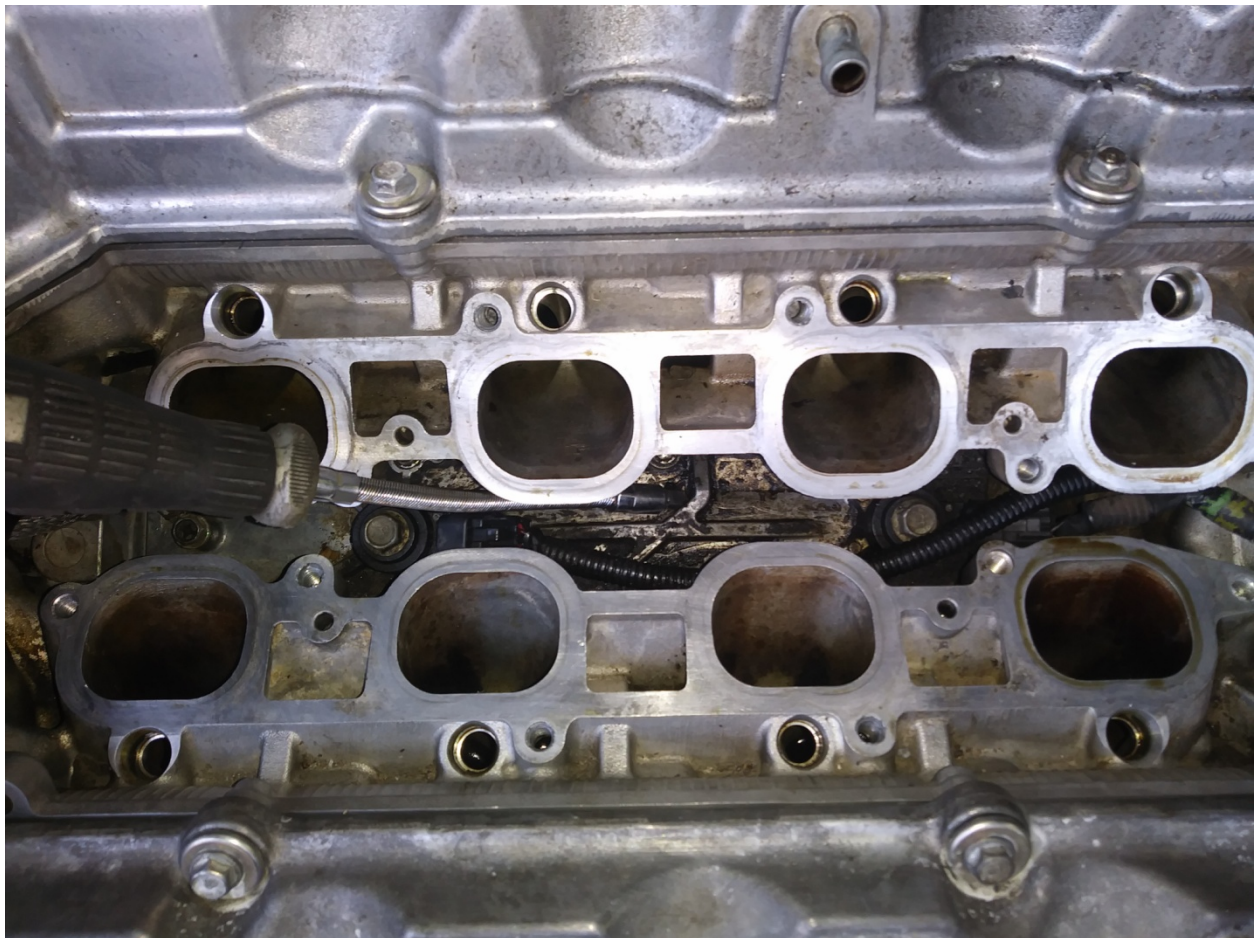
The trusty V8 with 251K began clucking like lose bolts in a can. At first, I thought the noise emanated from a serpentine idler pulley with a dry bearing, but no, it was the counterbalance shaft. The shaft sits between the two cylinder heads and deep inside the motor. The shaft has front and rear sealed bearing that are not lubricated by motor oil.

In reality, the bear seal fails due to time and heat; the dry bearing begins to chirp. To keep the vehicle, I have to change the bearings or find a way to lubricate them. Typically, the rear bearing, between cylinders 7 and 8, is the first to fail.

Examine the picture closely; the screwdriver tip rests on the CBS cover; the knock sensor (left and right) fasteners were removed to access the CBS cavity and fill with lubricant. The large openings lead to 2 intake valves/cylinder and companion dime size holes are for the fuel injectors. The cabling is for the knock sensors.

Not anxious to remove the intake manifold, the Bank 1 exhaust manifold and cylinder head, I decided a work around was required. (Creativity is a wonderful thing.) Removing the intake manifold, fuel injector rail and other plumbing exposed the CBS cover. On the cover are two spark knock sensors. Upon removing both, I was able to peer through the opening into the chamber, which appeared dry and not crusty.

Conjecturing my 2006 V8 was one of the pre weep hole motors, I could fill the cavity with 90 weight gear lubricant to lubricate the ball bearings. Shortly after pumping a pint of 90W into the chamber, I observed a puddle on the floor. Yup, it had a weep hole. This wasn't going to work. Then, I reasoned, why not pump graphite lube with a consistency greater than honey into the chamber. Heat from the engine would cause it to flow, but ever so slowly. One tube of graphite grease later, I replaced the knock sensors and intake manifold.
