Bob's Tech Tip

Random electronic failures plagued the jet boat. No amount of wire fault tracing disclosed the culprit. So work-a-rounds employing relays and new wiring made instruments, lights and pumps function.

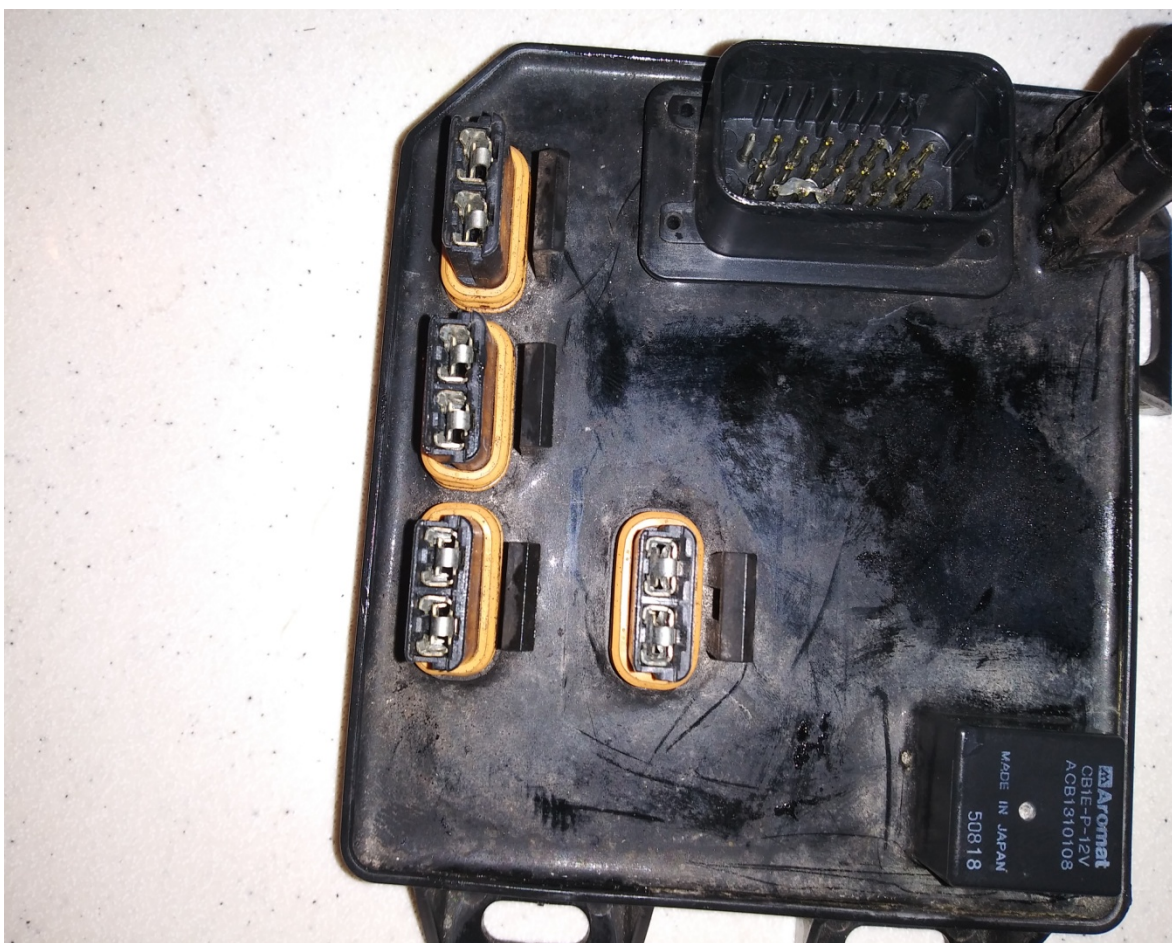
Last week, out on the lake, all electronics quit. Fortunately, the ignition is powered by a separate magneto which enabled me to return safely to the dock. At the shop, I began to wiggle wires and smoke scented burning circuit board wafted from the hatch. I cut the master power switch and found the source, a control circuit board in a tray covered with a thick coat of epoxy to protect against moisture. The technical term is "potting"; a process of filling an electronic assembly with epoxy to protect against moisture and corrosive agents. See the example below.

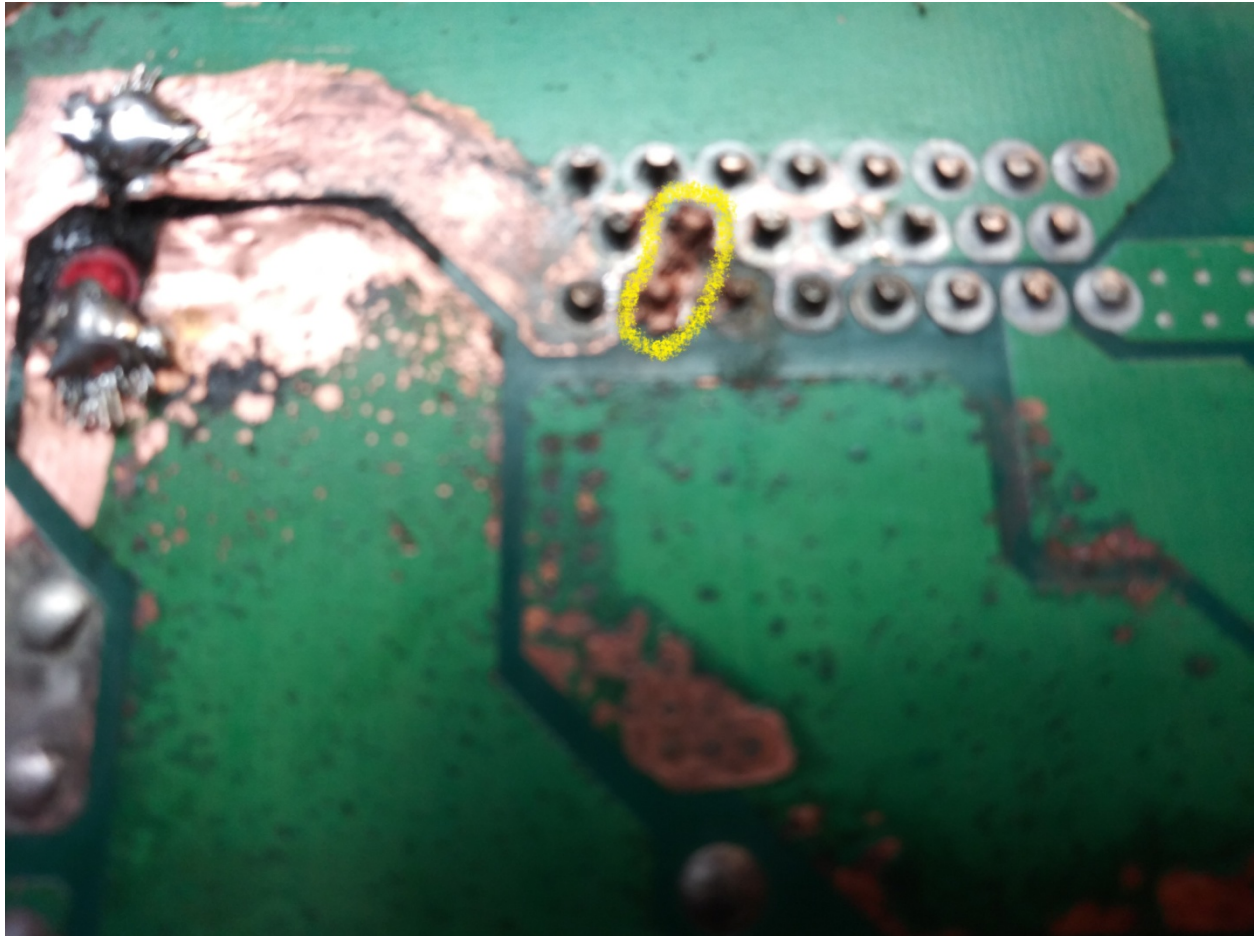
The repaired circuit board awaits installation. I plan to seal the bottom with a clear spray urethane; then, place the board in the tray and seal it by placing a bead of silicone along the edge of the circuit board and the tray.

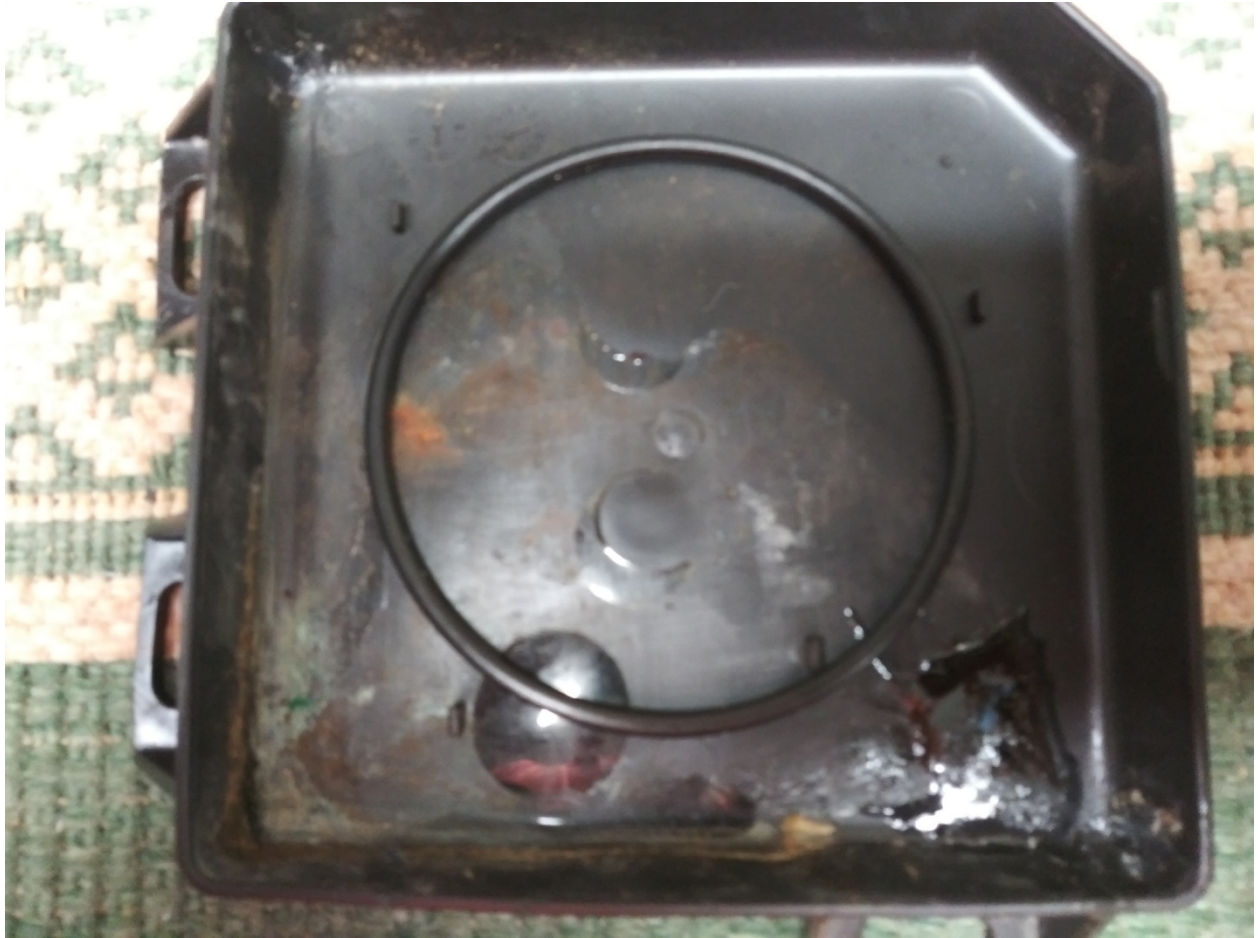
The tray must be prepared to receive the circuit board. It is imperative to have an air gap between the bottom of the circuit board and the tray to prevent any intruded moisture from touching the board and shorting out any circuits. I placed a retired Volvo "O-ring" oil filter gasket on the tray and set the circuit board on top.
