Failure of a Driveshaft CV Coupler

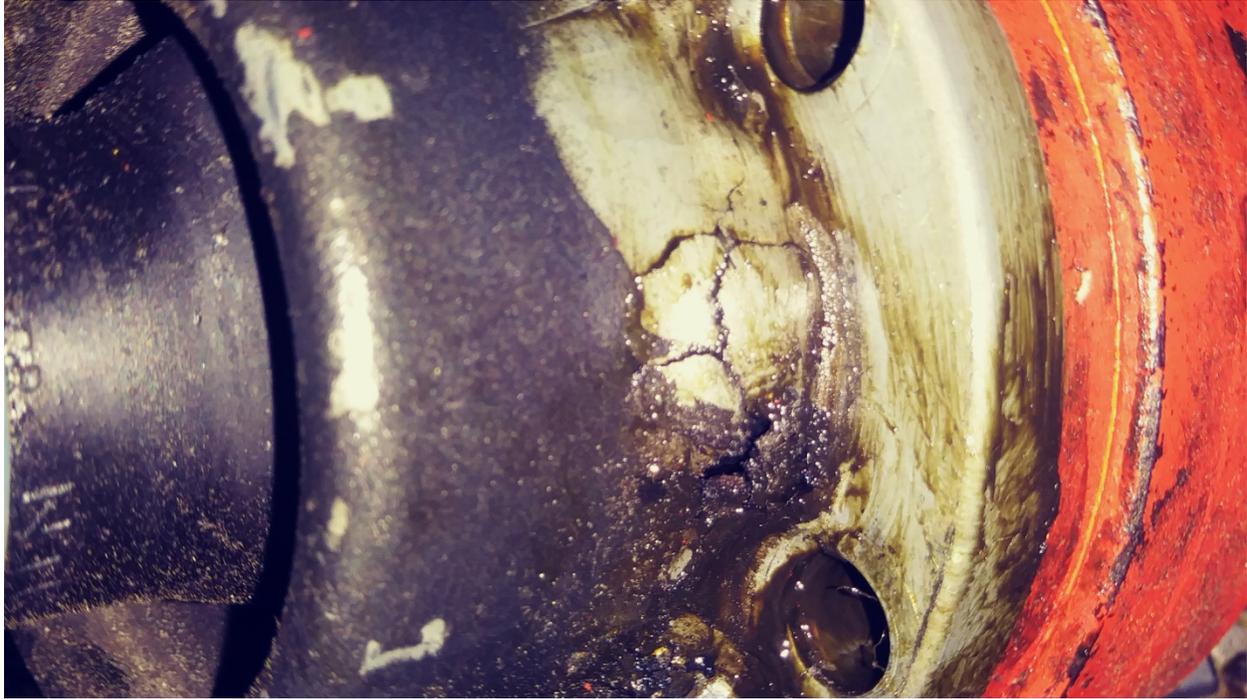
It began with a bit of vibration, then a squeak from the drive line of the Cross Country. 230K miles on the digital clock. A peek beneath the car disclosed a grease stripe on the underbody above the rear drive shaft coupler, which is a CV joint. A closer look revealed the marble size ball bearings were protruding from the front dust/retaining cover of the CV assembly.

I knew it had to be changed so a quick trip to Cary Volvo's Parts Department ensued. I approached Jess Castro, who is exceptionally knowledgeable about Volvo parts and applications, for a replacement. He said, "No luck kiddo, the CV joint is not available as a separate part, you've got to replace the W H O L E driveshaft."

I reasoned that it wasn't necessary to remove and replace the driveshaft, but just the CV joint (which is what I planned to do in the first place). A donor shaft from a salvage yard was acquired and I set about removing its CV coupler. First the rear metal dust cover must be removed, then the retaining C-clip from the drive shaft spline. A gear puller is used to extract the CV coupler from the spline. Easy enough. 5 minutes later it was off. In another 5 minutes the bad CV coupler was off; you can see the bearings protruding from the front dust/retaining cover. In another 20 miles, the axle would have dropped on the road. Not good!

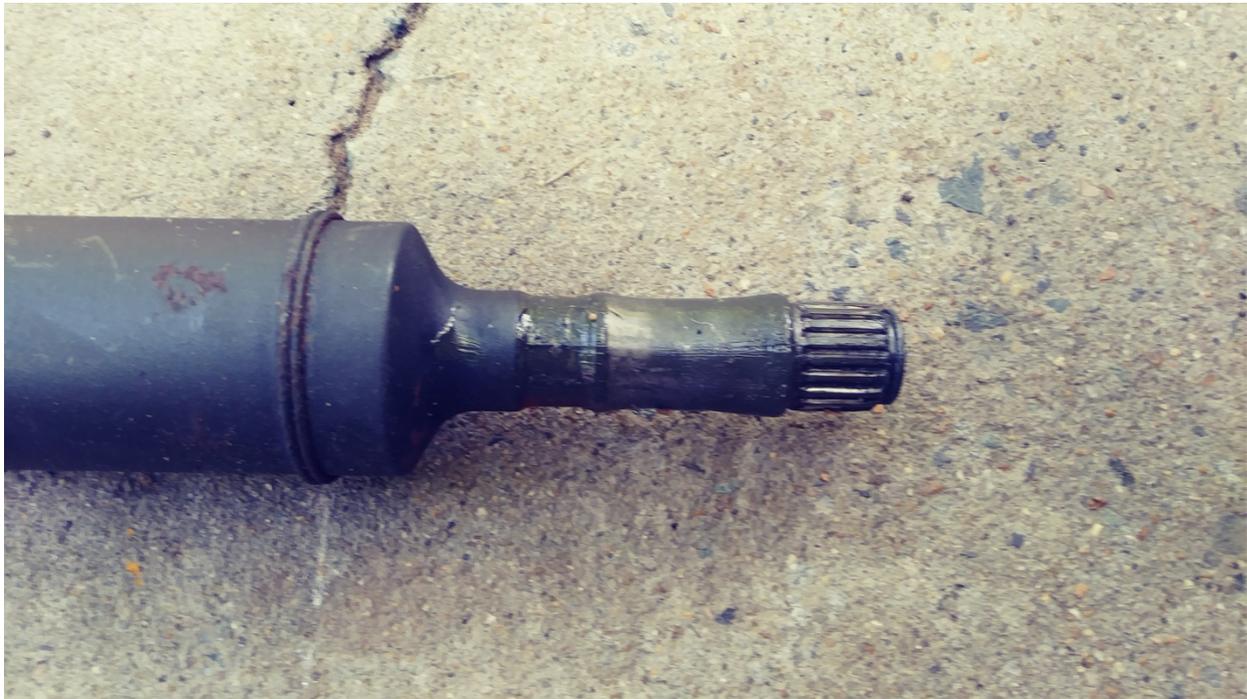
The donor driveshaft spline (above). There is a CV joint at both ends. Since one was needed, I have a spare CV coupler. So a task that could have become labor intensive was simplified by replacing the worn part as opposed to the entire driveshaft. I do not understand why this component is not offered as a replacement item. If you can use the other driveshaft CV coupler, contact me by email.
