# The 2008 XC70 Saga

Forensic Analysis:

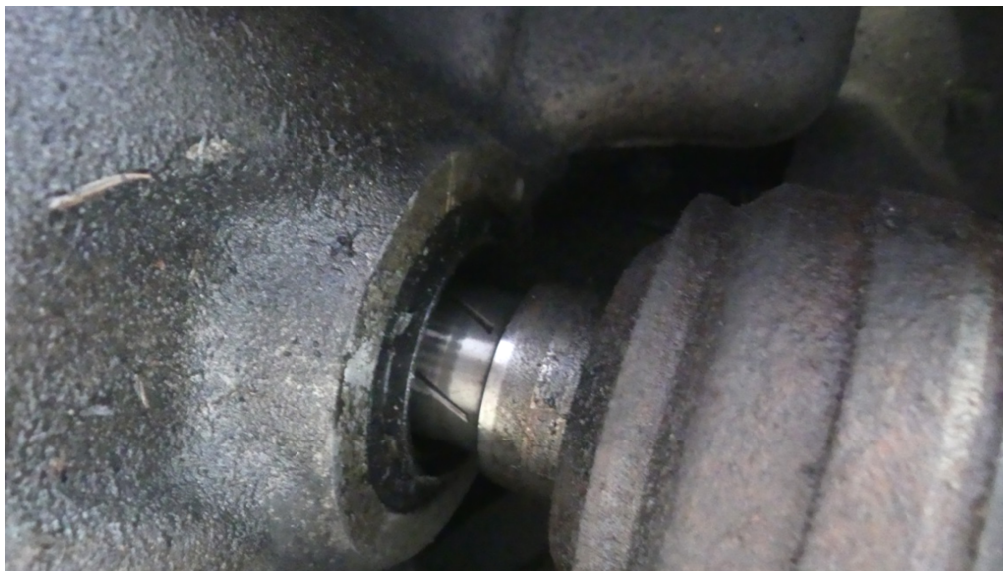
A week later I inspected the rear differential, instead of finding a snapped rear axle, I discovered the right rear axle had been spit out of the differential ~1" and no longer engaged the drive gear; no snapped axle.

Right Rear Axle at Differential

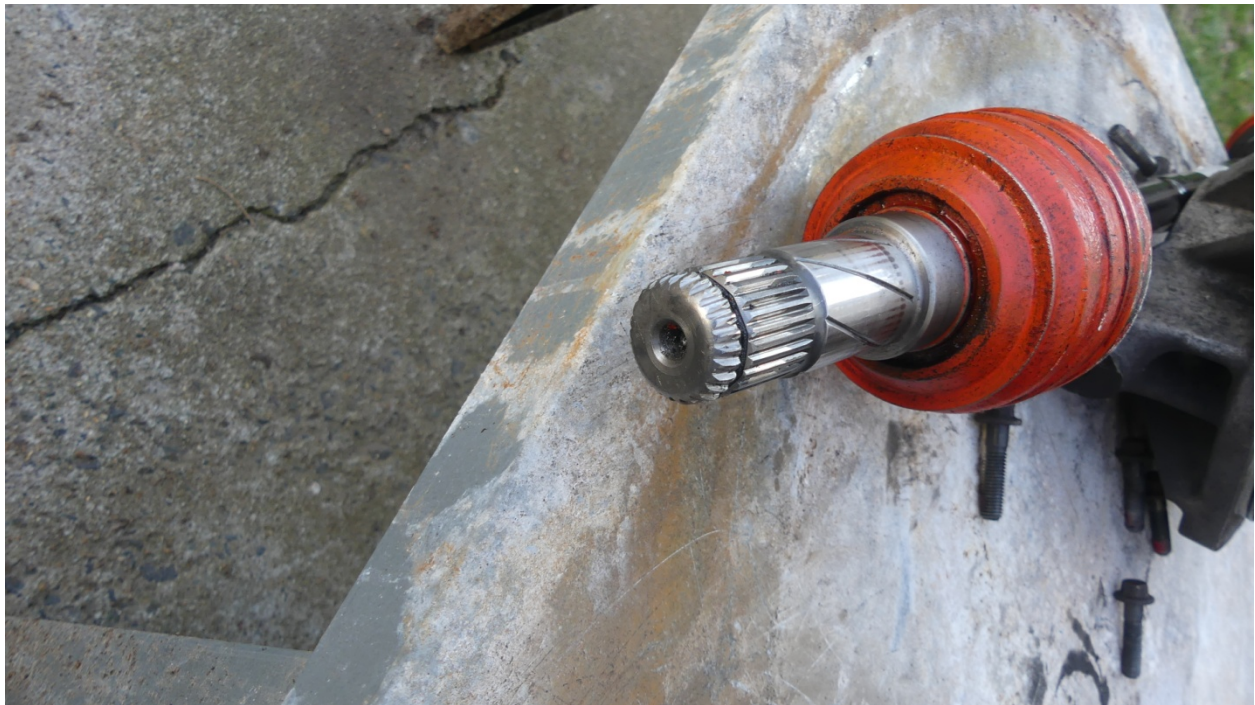
For fun, I tried to seat the axle without success. Subsequent post removal inspection revealed the axle gear spline, a rotating feature of mating gear assemblies, preceding the retaining ring

(see next photo) was distorted by torque twist thus, preventing the spline following the retaining ring from engaging the axle gear. The torque twist occurred when the gear froze and the rear wheels continued turning due to the vehicle's momentum.

Spline Tip Misaligned/Twisted by Axle Gear Torque.

Further inspection revealed the axle housing had been beaten severely by a hammer in a failed attempt to seat it in the axle gear. The repair shop likely gave up and believed the axle to be seated; their failure was not having sufficient curiosity to determine why the axle could not be fully inserted. *[By not rendering a diagnosis, the shop avoided the liability of a faulty repair. The damaged axle should have been replaced as part of the factory differential swap; thus negating the reoccurrence of another replacement.]*

The axle remained partially inserted and the oil seal open (see earlier photo) which resulted in oil loss and seizure of the pinion shaft and internal gears. The seizure of the pilot shaft did not damage the front angle gear because the haldex continued to rotate. Given the foregoing, it is no wonder the AWD did not function.

The replacement right axle arrived from Erie Vo-vo. I needed to resize the compression-lock ring in the axle tip because they become distended when jerked from the retaining ring of the axle gear upon removal. With the ring on the axle, heat it moderately with a propane torch and then crimping the ring against the shaft with a pair of pliers, hold until cooled. To install, first insert the hub end, then slide the other into the differential, give it a powerful shove to lock it firmly in the ring receiving slot in axle gear. Over crimping the ring will prevent the axle from locking; remedy by removing the axle and expanding the retaining ring slightly, then reinsert.

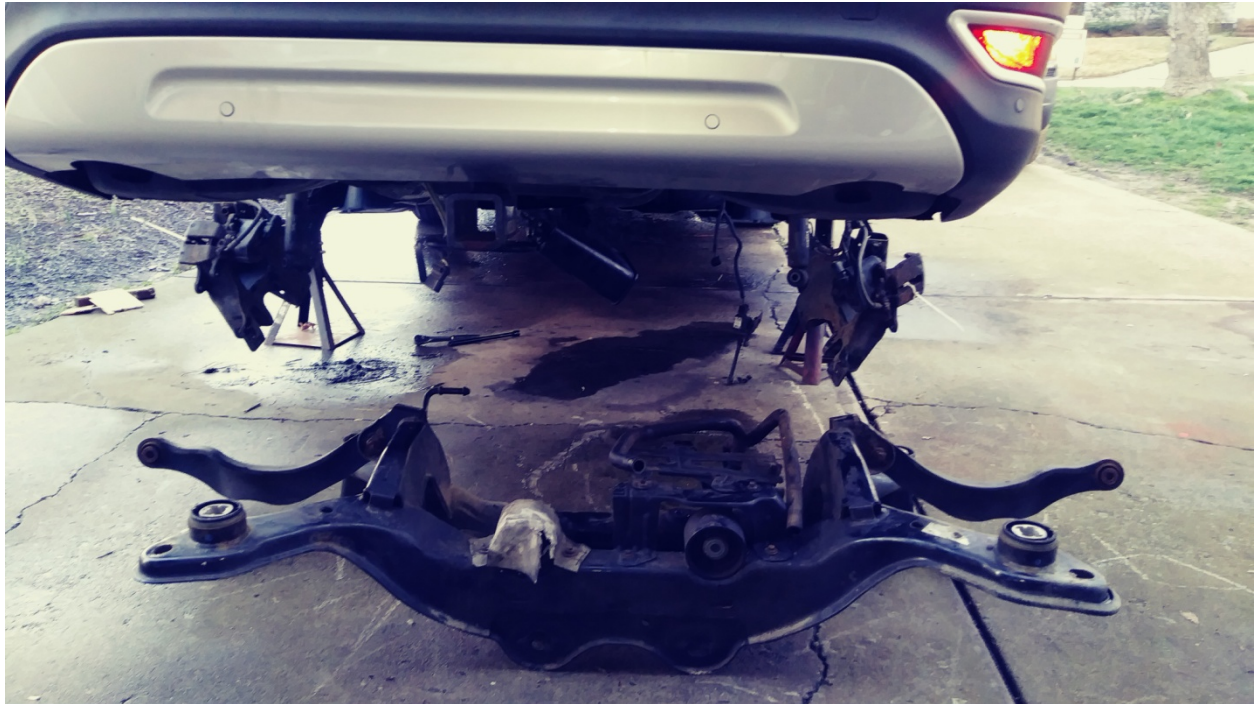
Rear Differential/Haldex Cradle

So why does the cradle have to be lowered? Well, one of the three bolts fastening the differential to the cradle is installed top down, preventing the differential from being removed without lowering the cradle. A side or mount design would facilitate repair. But you think the manufacturer cares, NA-DA; because luxury car owners, as a class, are expected to pay exorbitant repair expenses or trade-up.

I discovered the 4 cradle support bolts were torqued north of 1300 ft. lbs. A 1/2" breaker bar equipped with a 15mm impact socket and a 3' pipe extension loosened them. When I believed one would snap; I muttered my mantra: don't jerk, just apply steady increasing pressure and the tightest bolt will loosen without snapping. They did!

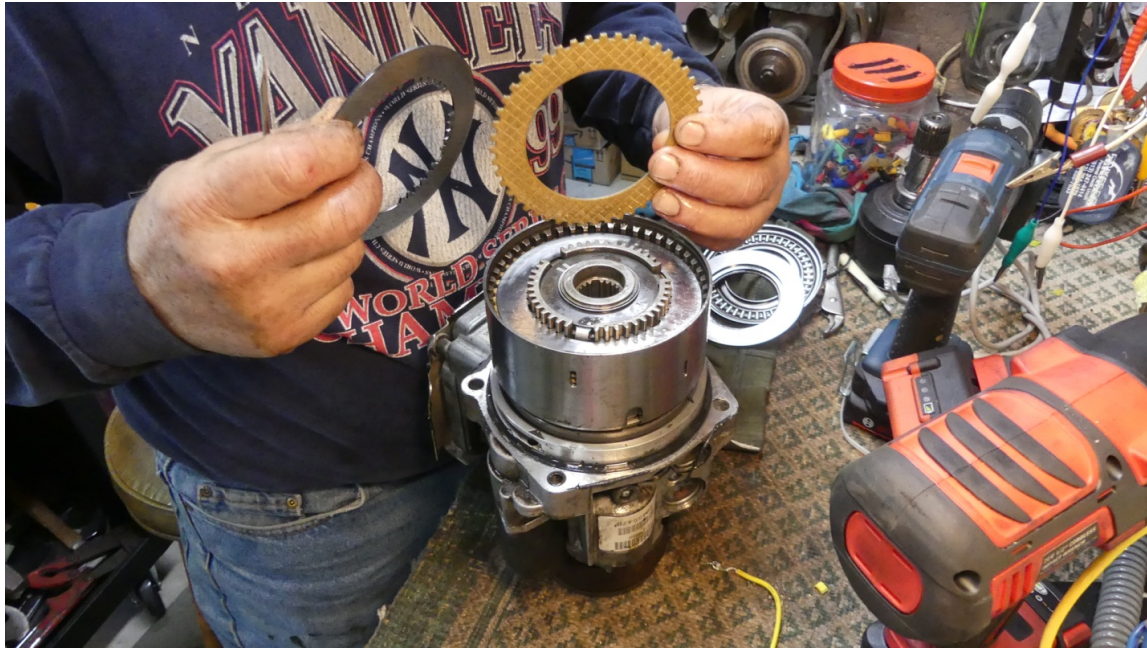
This was an opportunity to inspect the clutch pack, a combination of clutch disks and stainless steel pressure plates. The fiber clutch disks (yellow) and stainless plates had no noticeable wear.

Haldex Has Alternating Clutch Disks and Plates.

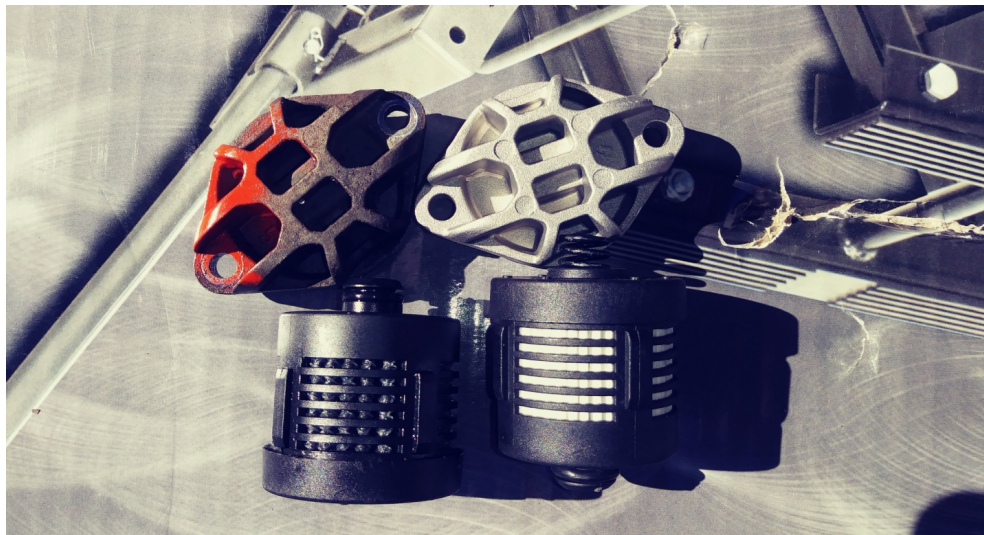
After cleaning, reassembly and replacing the retaining ring, I set about to inspect the haldex oil pump filter, which had been changed. (I paid Mack to change the filter 9 months earlier.) Surprise, it was filthy. I thought to myself, the filter had not been changed.

Left: Old Filter and Cap - Right: Replacement

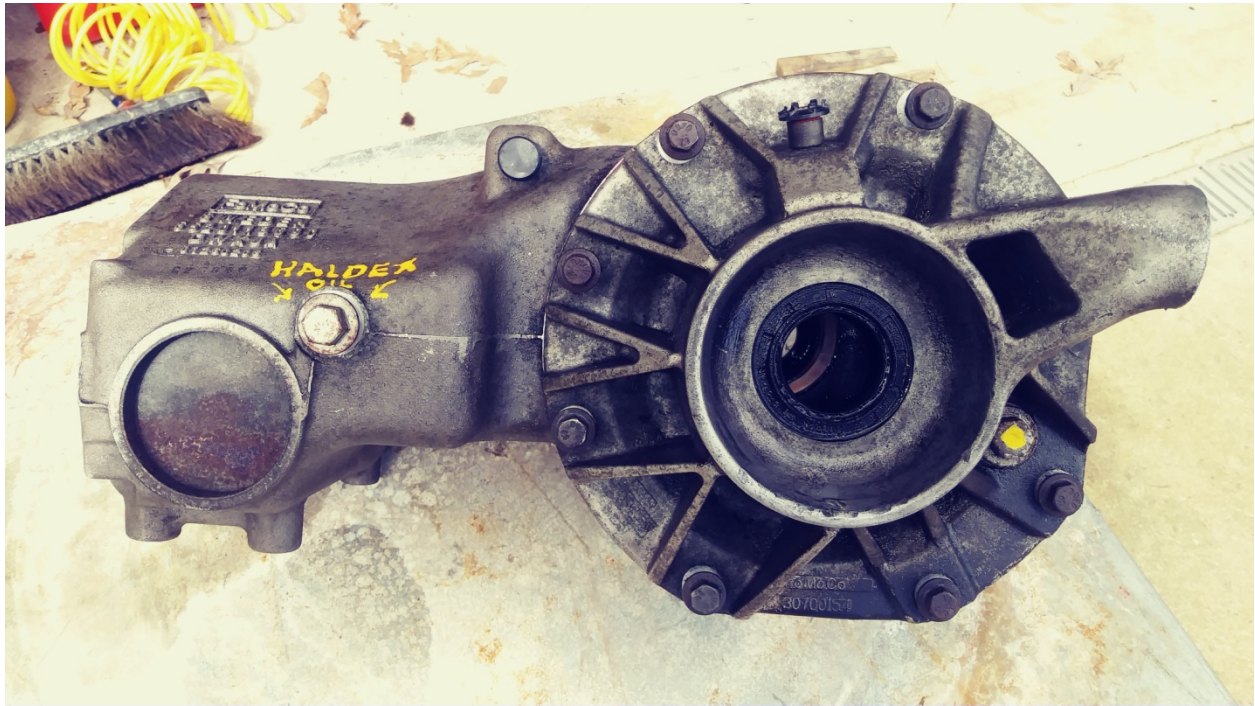
The filler plug on the differential's nose, which is where the clutch packs reside and the rear one is the differential oil fill port.

Photo of Uninstalled Differential

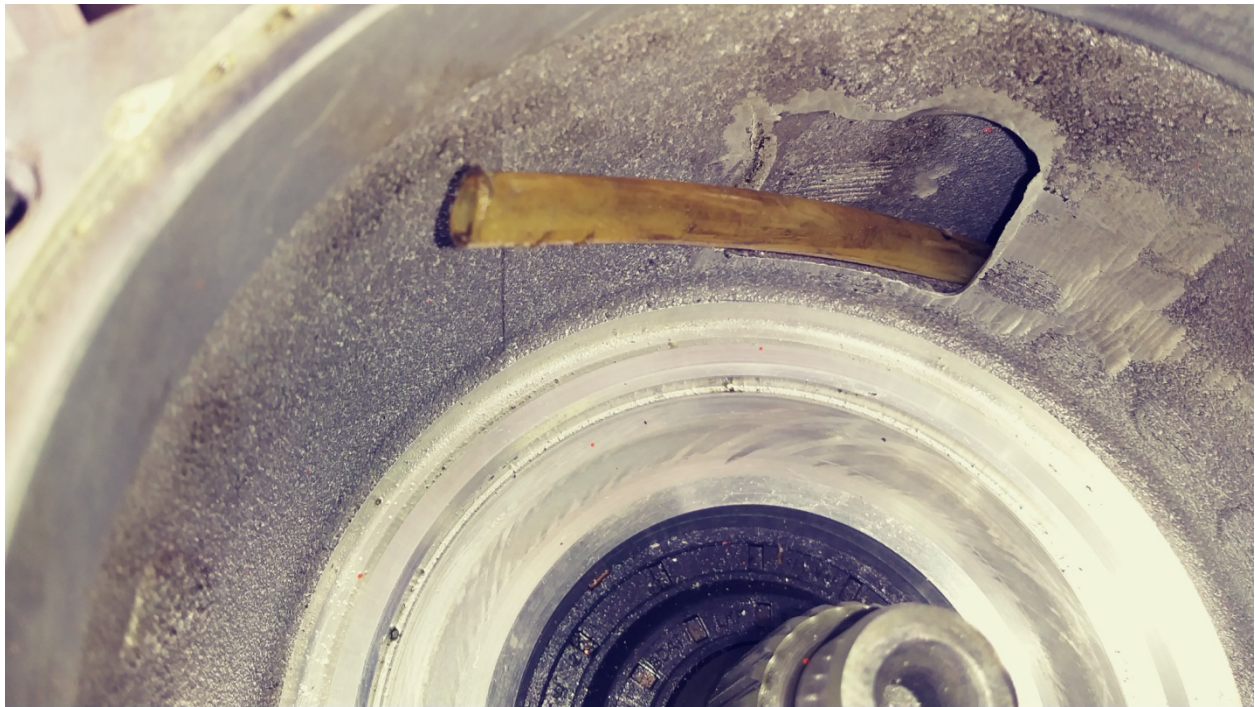
To fill the Haldex, insert the oil tube 6" into the port (left) because it fills from above. Port on right is for GL5 differential oil. (See previous photo)

View of Haldex Clutch Pack Chamber and Oil Fill Tube

If the tube is not inserted upward about 6" into the clutch pack cavity, oil will run out the access port and you'll mistakenly believe the cavity filled, when it is not. Big problem, the clutch pack will burn out within a minute or two of driving and should it seize, do all kinds of damage to the driveline. Fill the cavity with .7 liters of mineral oil.

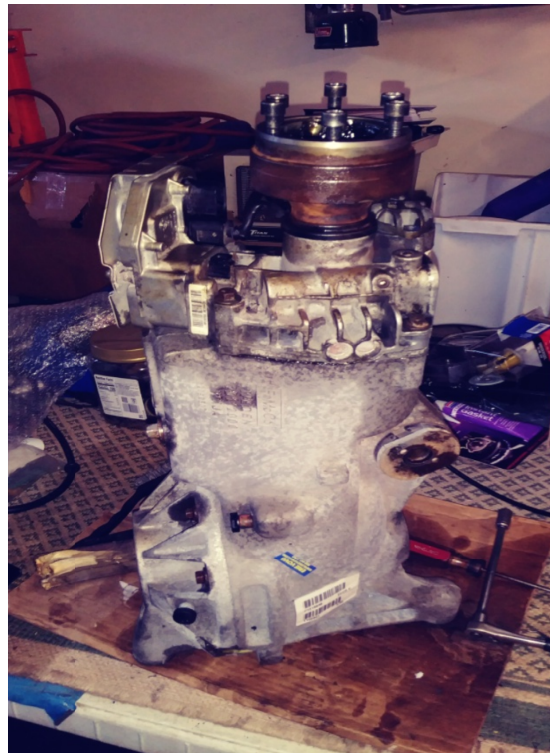
I unpacked the donor differential I'd received from Erie Vo-vo, mounted the haldex and bolted it to the differential.

Differential and Haldex Mated

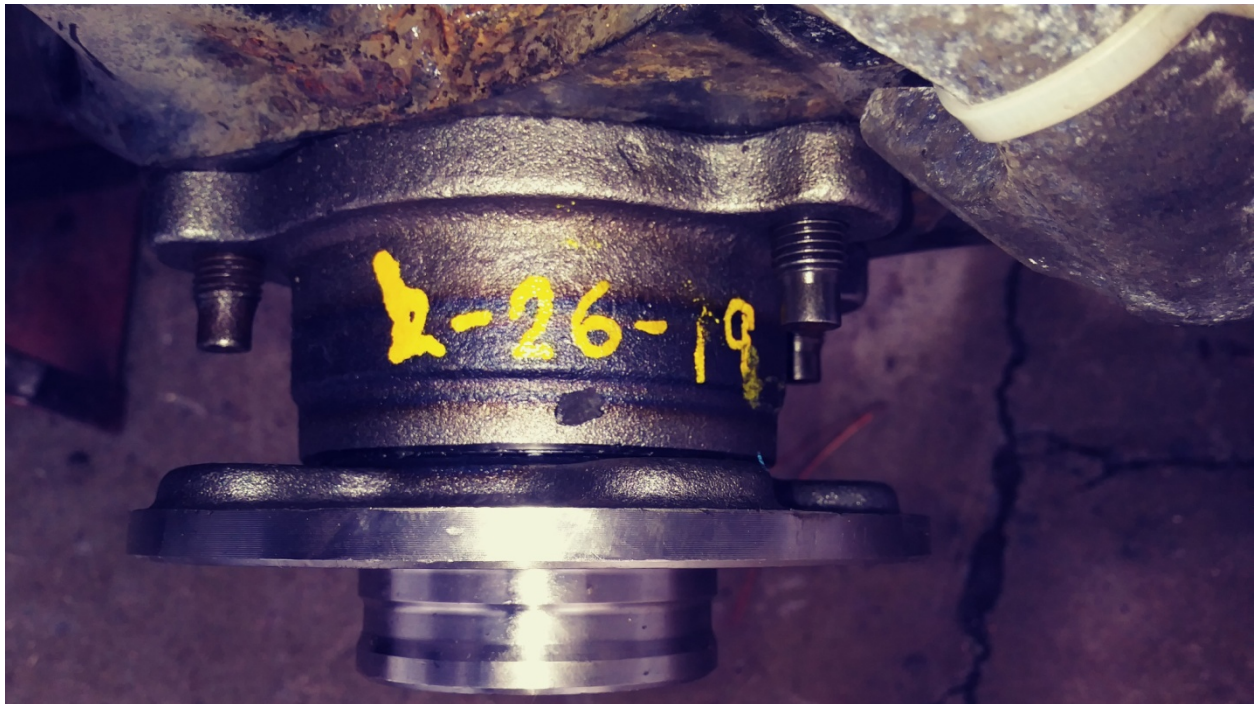
The new rear wheel hubs were installed each marked with the installation date. I use a yellow paint pen to date replacement parts; should I return to a problem, I know when components were replaced or serviced.

Dated Hub

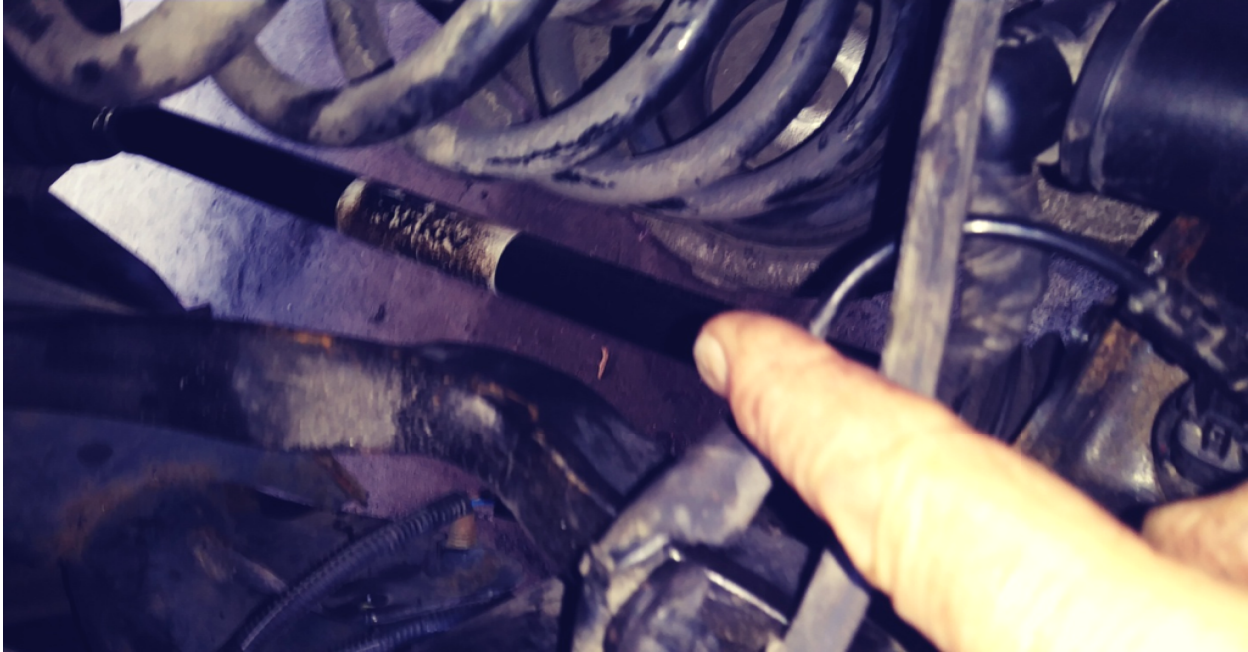
Pointing to Replacement Right Axle

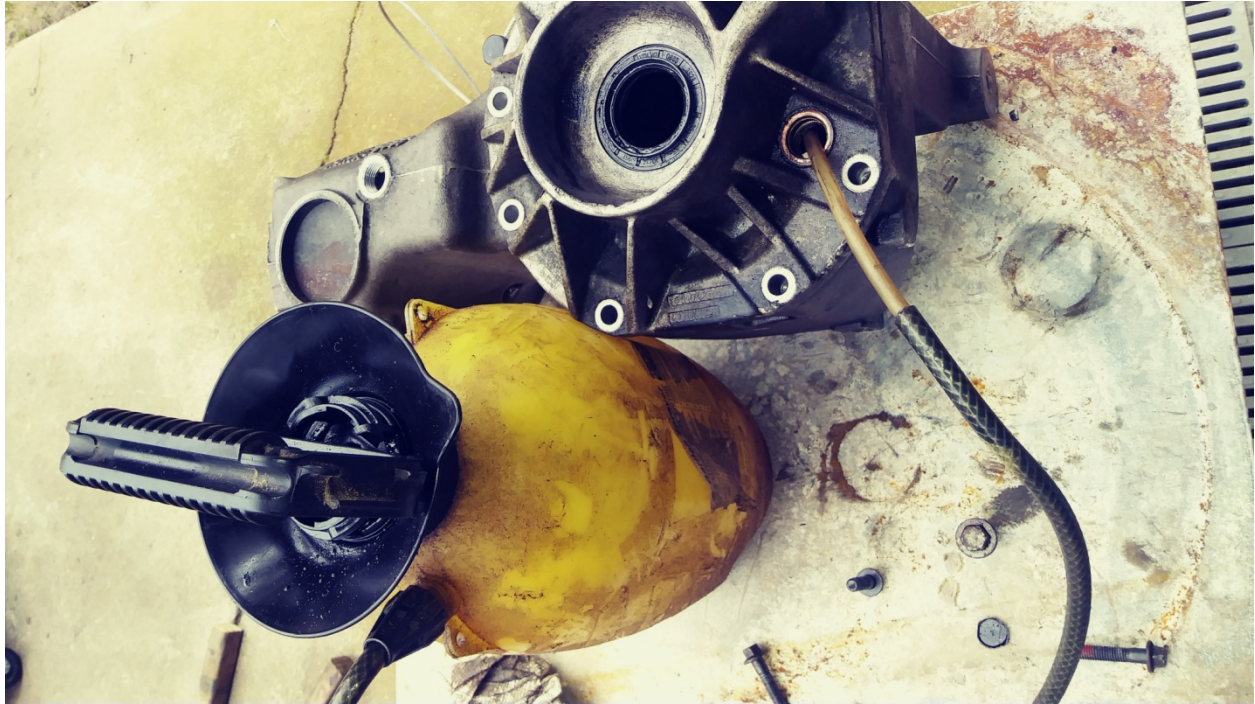
Let's talk about putting heavy gear oil in a gear box from beneath a vehicle. Years ago, I found it impossible to use a squeeze bottle to push heavy gear oil into a gear box port. My solution is to pour gear lube in a plastic 1 gallon pump sprayer. Then pressurize the sprayer to push the oil up and into the gear box. Place a 1-foot length of clear plastic hose at the end to view fluid flow. Release pressure when oil drips from filler port to stop oil flow; then cap the opening.
