# Where's the Heat?

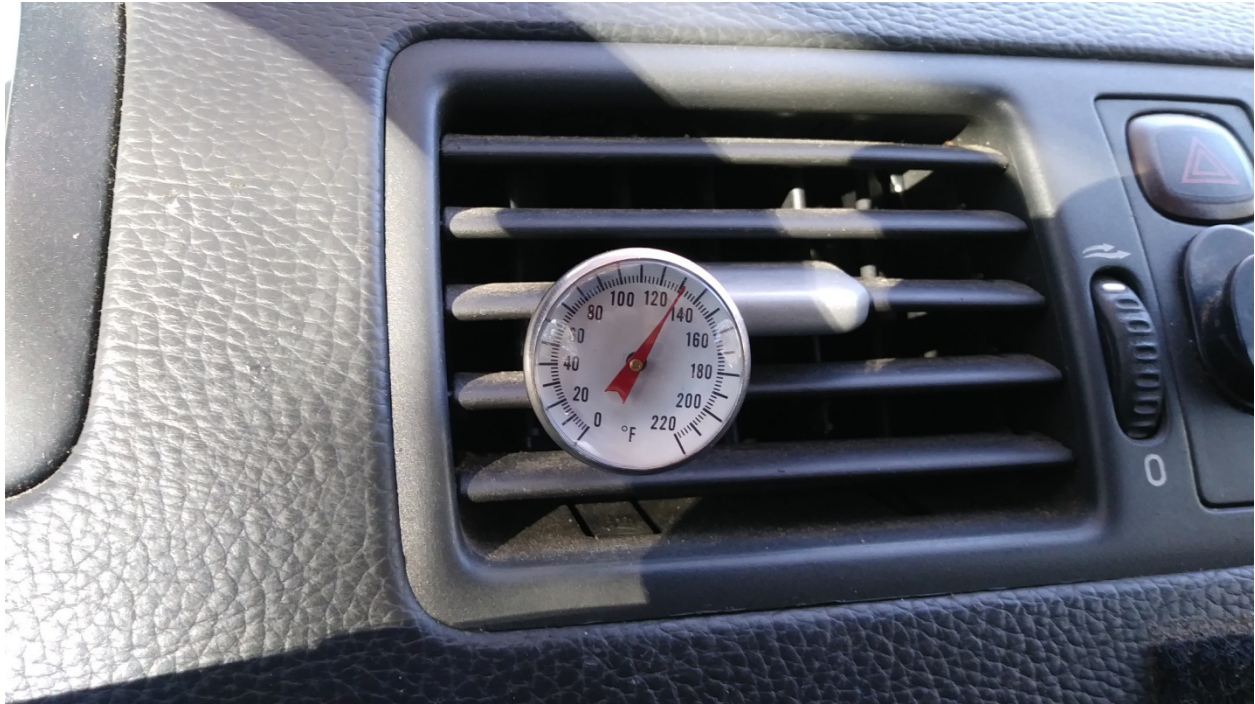
Thermometer shows the cabin air temperature post heater core swap.

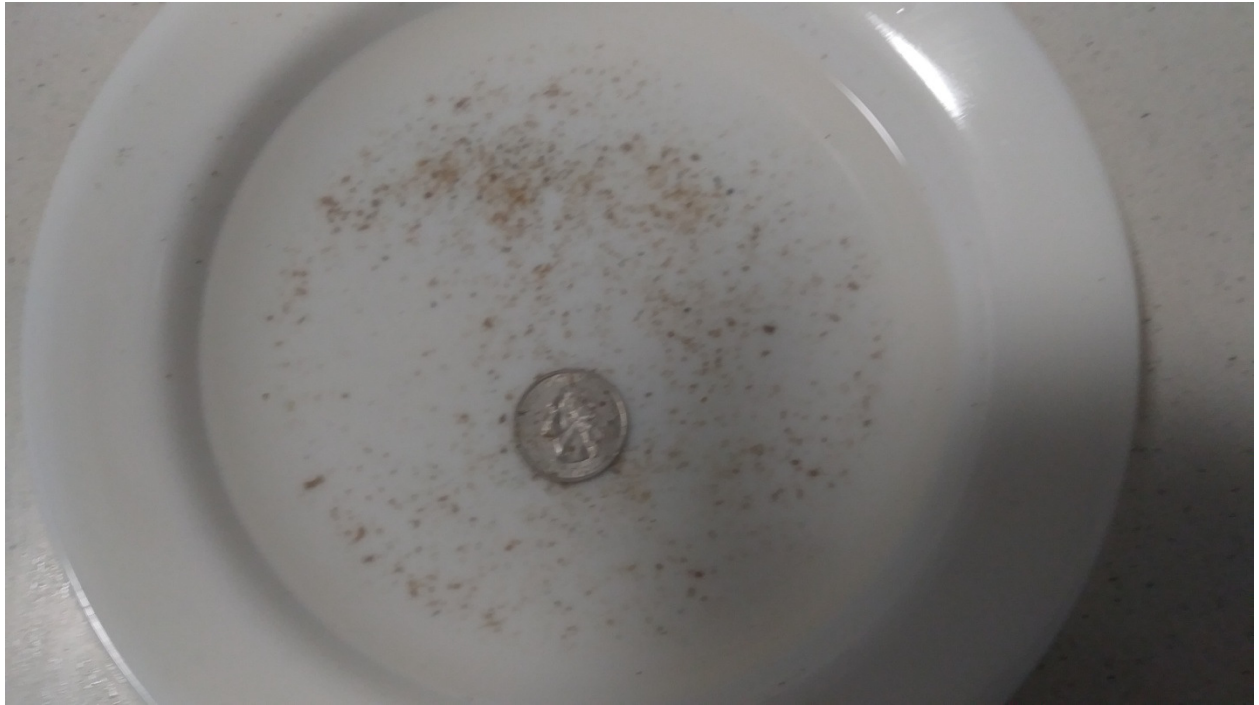
Anatomy of a failed heater core.

To test a heater core, fill core with clean water and slowly drain onto a white dinner plate. If you see grit, discard the core (see picture). Salvage yard donor cores should be tested to avoid replacing a failed core with one about to fail.

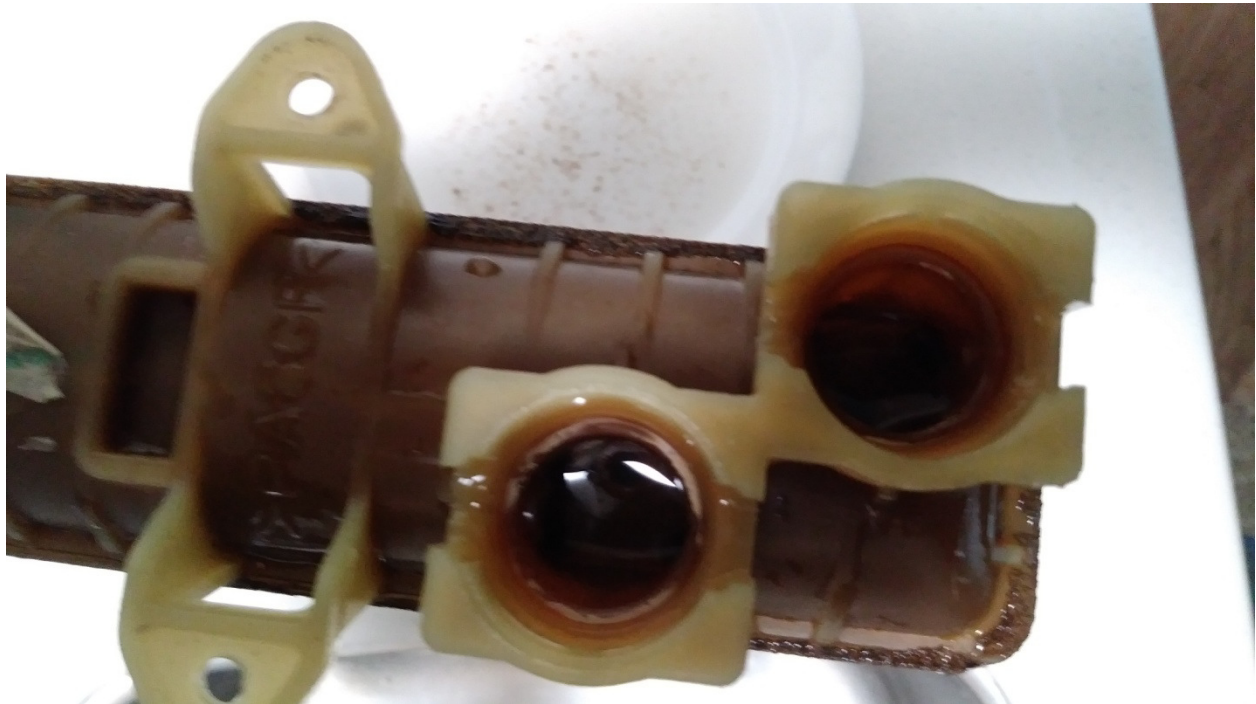
## Tube inspection

Slowly pour water into one of the two heater core openings, if water fills one side and not the other, the core is plugged (see picture). If you shine a light into the core, you may see the scale inside the tubes. Through either opening, thread a fine stiff stainless steel wire into a tube to determine whether it is clogged. If obstructed, sediment will be dislodged and emptied into the plate with drain water. If both plastic core end caps are not nearly the same temperature while the motor is running, the core is seriously obstructed.
