Bizarre Serpentine Belt Failure

Has this happened to you?

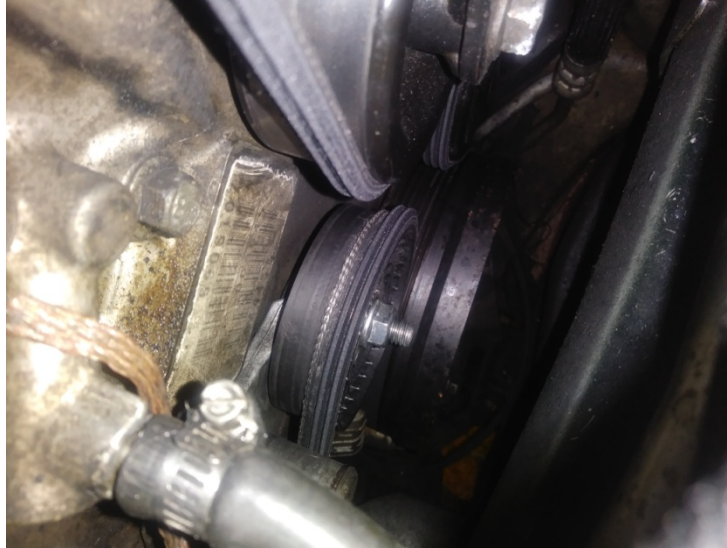
The serpentine belt shows wear on half the surface; it appears to be scrubbing something but there is no obvious contact point.

I've encountered this phenomenon several times and never understood how a serpentine belt could wear on one side. Clearing the guide way and replacing the belt never solved the problem.

The reason is a bearing on an idler pulley is beginning to fail; as heat (friction) is generated, the pulley rotates more slowly creating drag on the upper side of the belt as it is scuffed across the pulley surface. The resulting surface friction and heat cause the belt surface to wear, the metal wire belts fail and wrap around the crankshaft and accessory drive pulleys. A sign of pulley bearing failure is belt squeal under acceleration with engine at operating temperature.

The reason is that a worn bearing allows the pulley to tilt slightly and the belt area contacting the tilted surface experiences reduced drag, hence less wear.

The solution is to replace all serpentine belt pulleys or open, clean and repack each bearing with grease. The latter is more cost effective. I keep a supply of

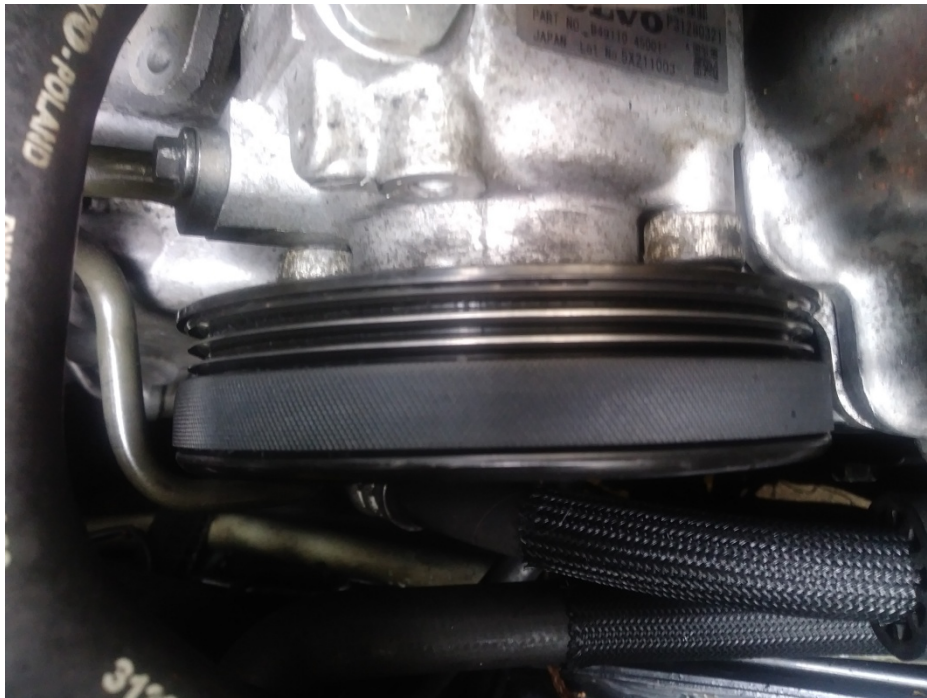
Eventually half the belt will disappear.

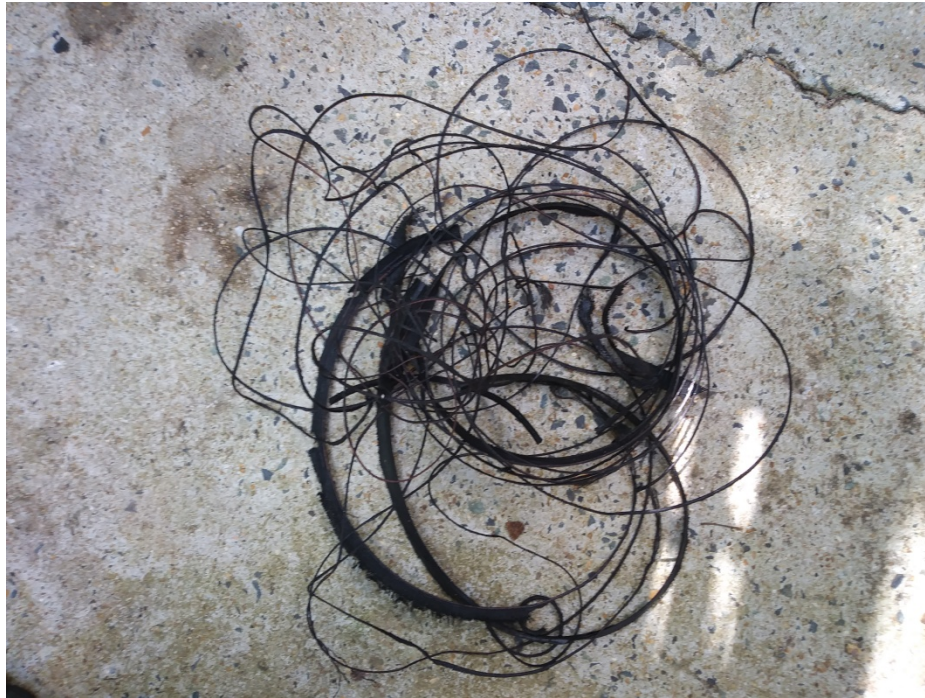
Look for the missing part to be tightly wrapped around the crankshaft and alternator pulleys. You'll have to clear each pulley and the pathway before installing a new belt.
